Storm Water Quality Inspection

Commons Waterway Sec 4 Unit 1

Monthly

Sep 25, 2019

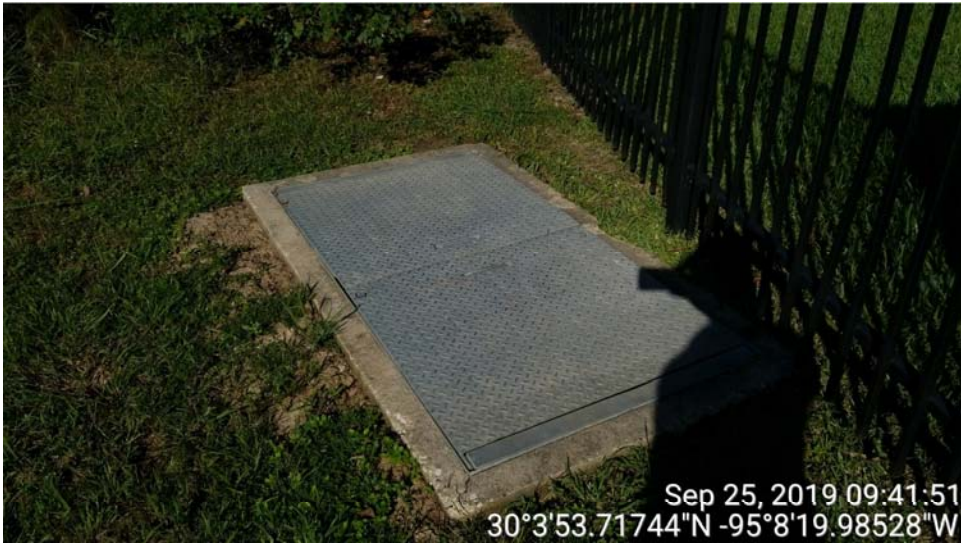
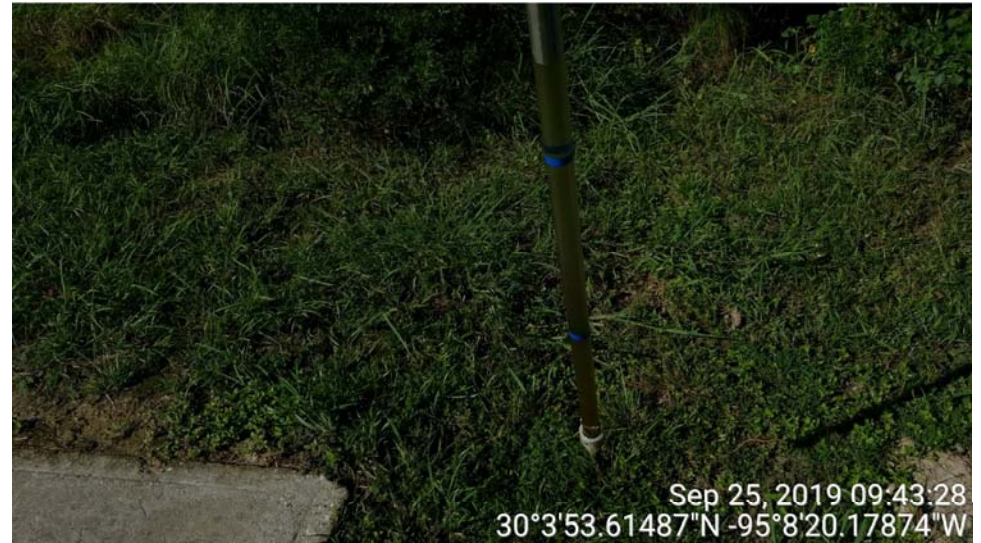
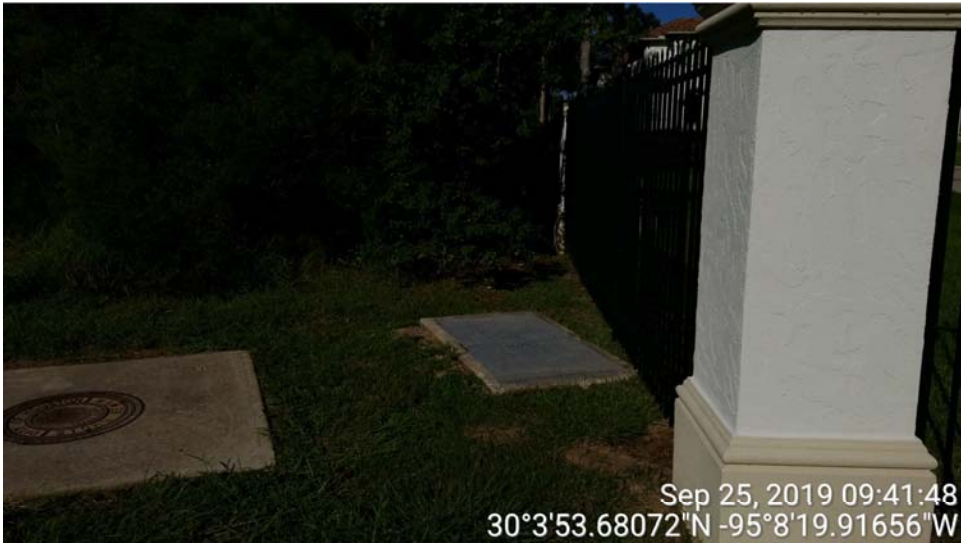
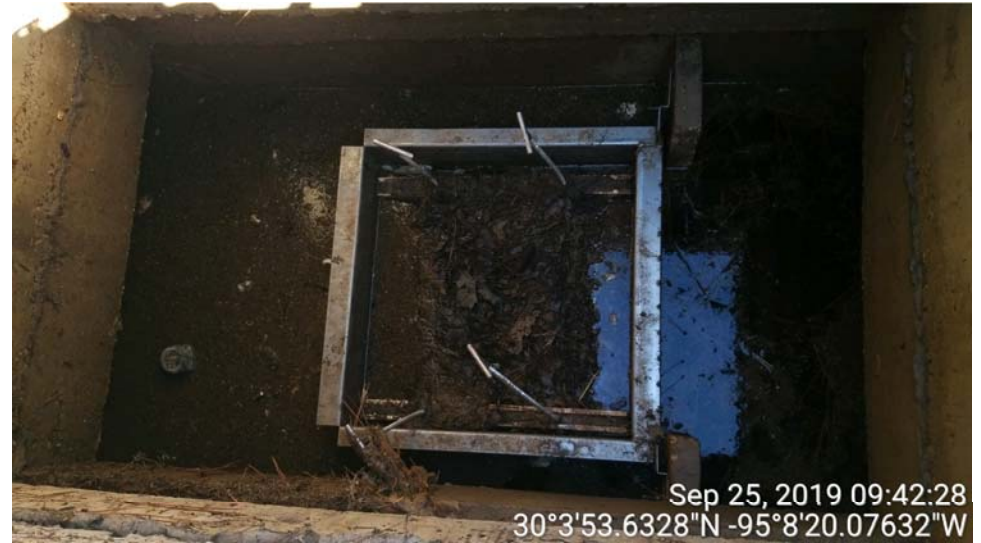
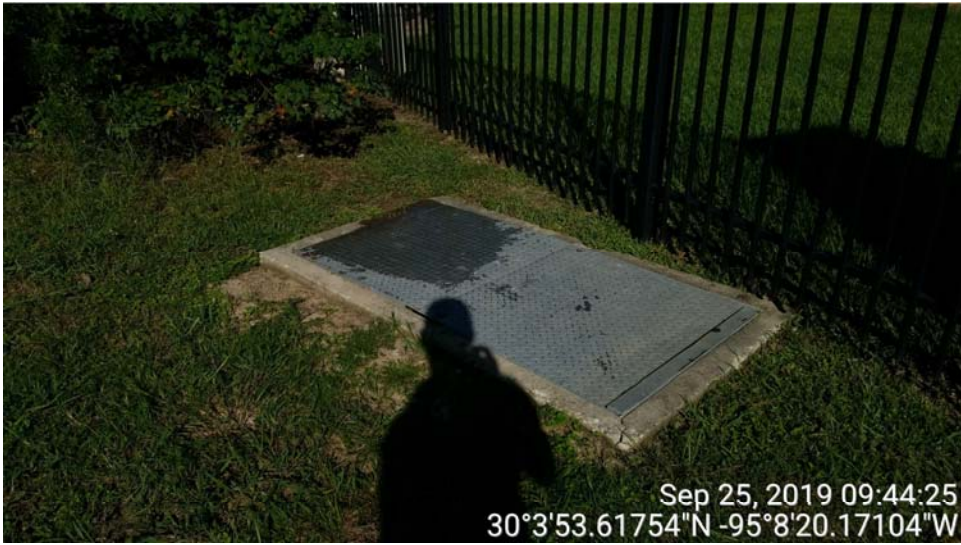
Unit working as designed.
